Technical Bulletin

Subject: **Control input blade terminal detachment during installation**

Product: SSC10-100
SSC10-150
SSC10-200

Document: TB-50A
Date: August 14, 2006

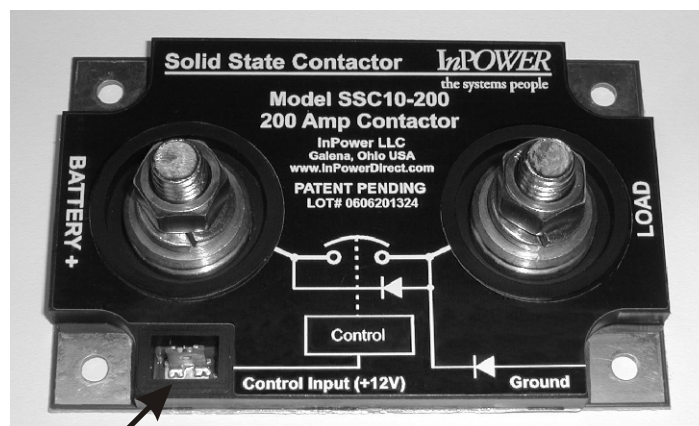
Control Terminal

Problem: The 1/4 inch faston blade control terminal is soldered to a circuit board pad on the module's base. Due to a soldering process problem on a small number of units, insufficient solder was applied, increasing the possibility of the terminal separating at the solder joint when external force was applied (connecting the mating terminal), or when a high rotational torque is applied to the terminal during installation.

Solution: The manufacturing process has been corrected to apply the appropriate amount of solder. The circuit board has also been changed to increase the size of terminal mounting pad. On production units built before the circuit board pad size increase is implemented, a layer of epoxy will be placed at the base of the terminal, preventing terminal rotation.

1. Field units with detached terminals - Contact your vehicle manufacturer for module replacement, or contact InPower. **Do not attempt the repair the terminal.** Return the old units.
2. OEM production units. Contact InPower to arrange the return and replacement of units.
